**RENAULT** X40

**MOUNTINGS MAKING UP THE DOORS**

**TECHNICAL  
NOTE**

**116**

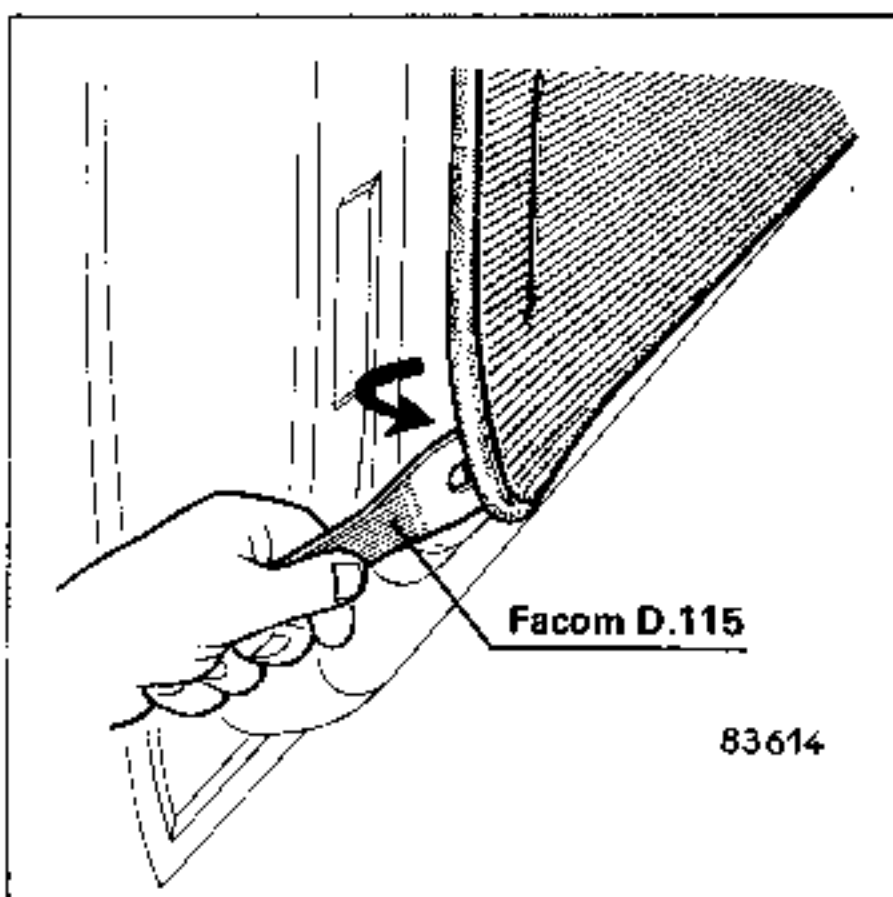
\* destroyed on removal

● Fastenings which can be recovered are dismantled using tool D.115.

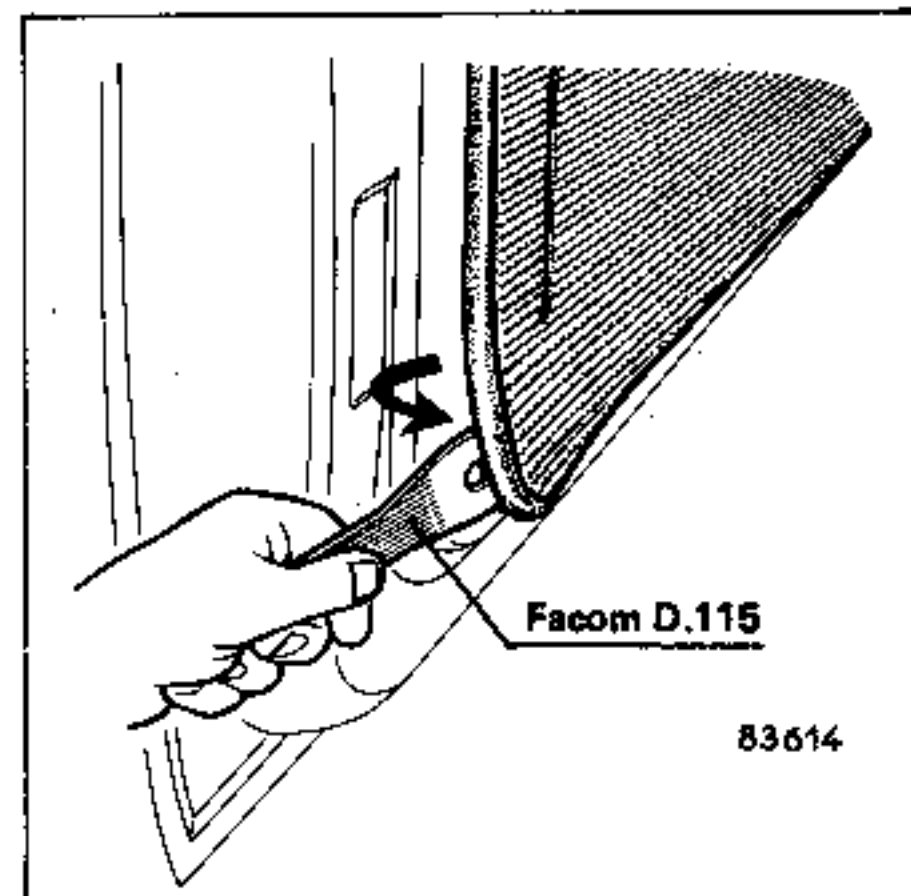
\* destroyed on removal

● Fastenings which can be recovered are dismantled using tool D.115.
