CONSUMABLES

AIR CONDITIONING

Wiring diagram

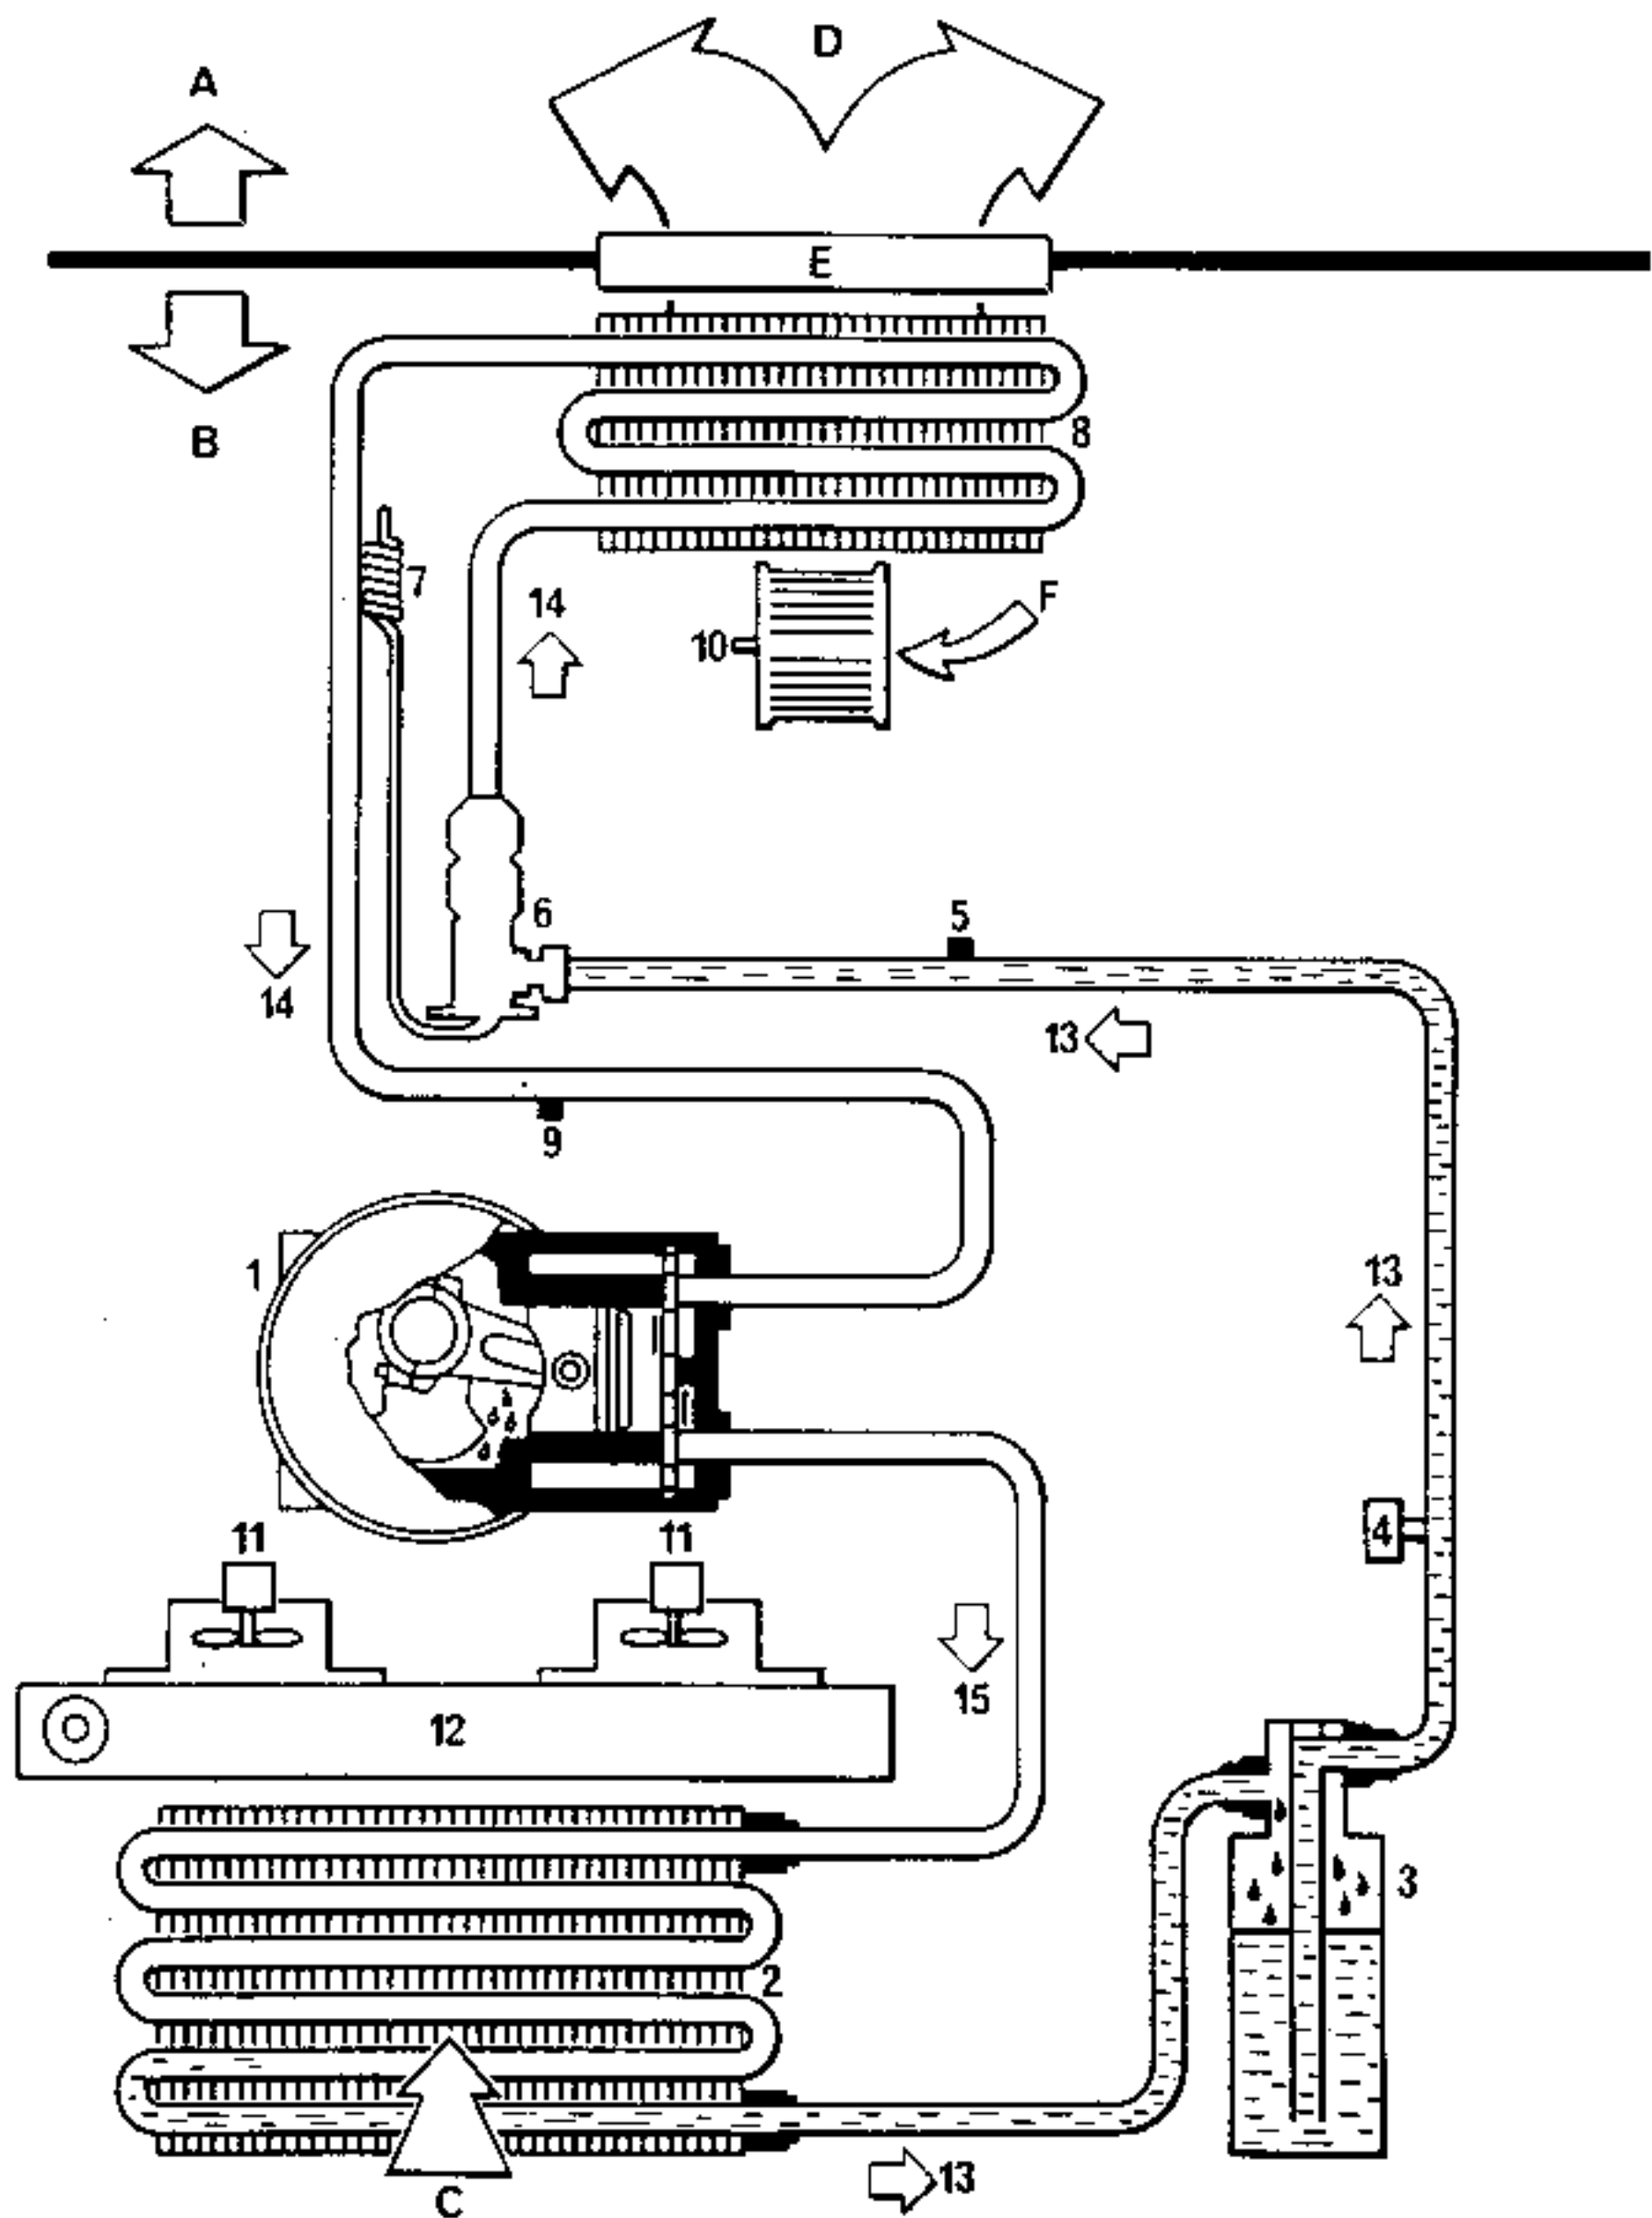
- A** Passenger compartment
- B** Engine compartment
- C** External air
- D** To air mixing chamber
- E** Scuttle panel
- F** External or recycled air

- 1** SANDEN compressor : SD 709
- 2** Condensor
- 3** Freon reservoir
- 4** Trifunction pressostat
- 5** High pressure bleed
- 6** Pressure relief valve
- 7** Pressure relief valve thermostatic control
- 8** Evaporator
- 9** Low pressure bleed
- 10** Heating and ventilation fan
- 11** Air conditioning fan
- 12** Engine radiator
- 13** High pressure fluid
- 14** Low pressure vapour
- 15** High pressure vapour

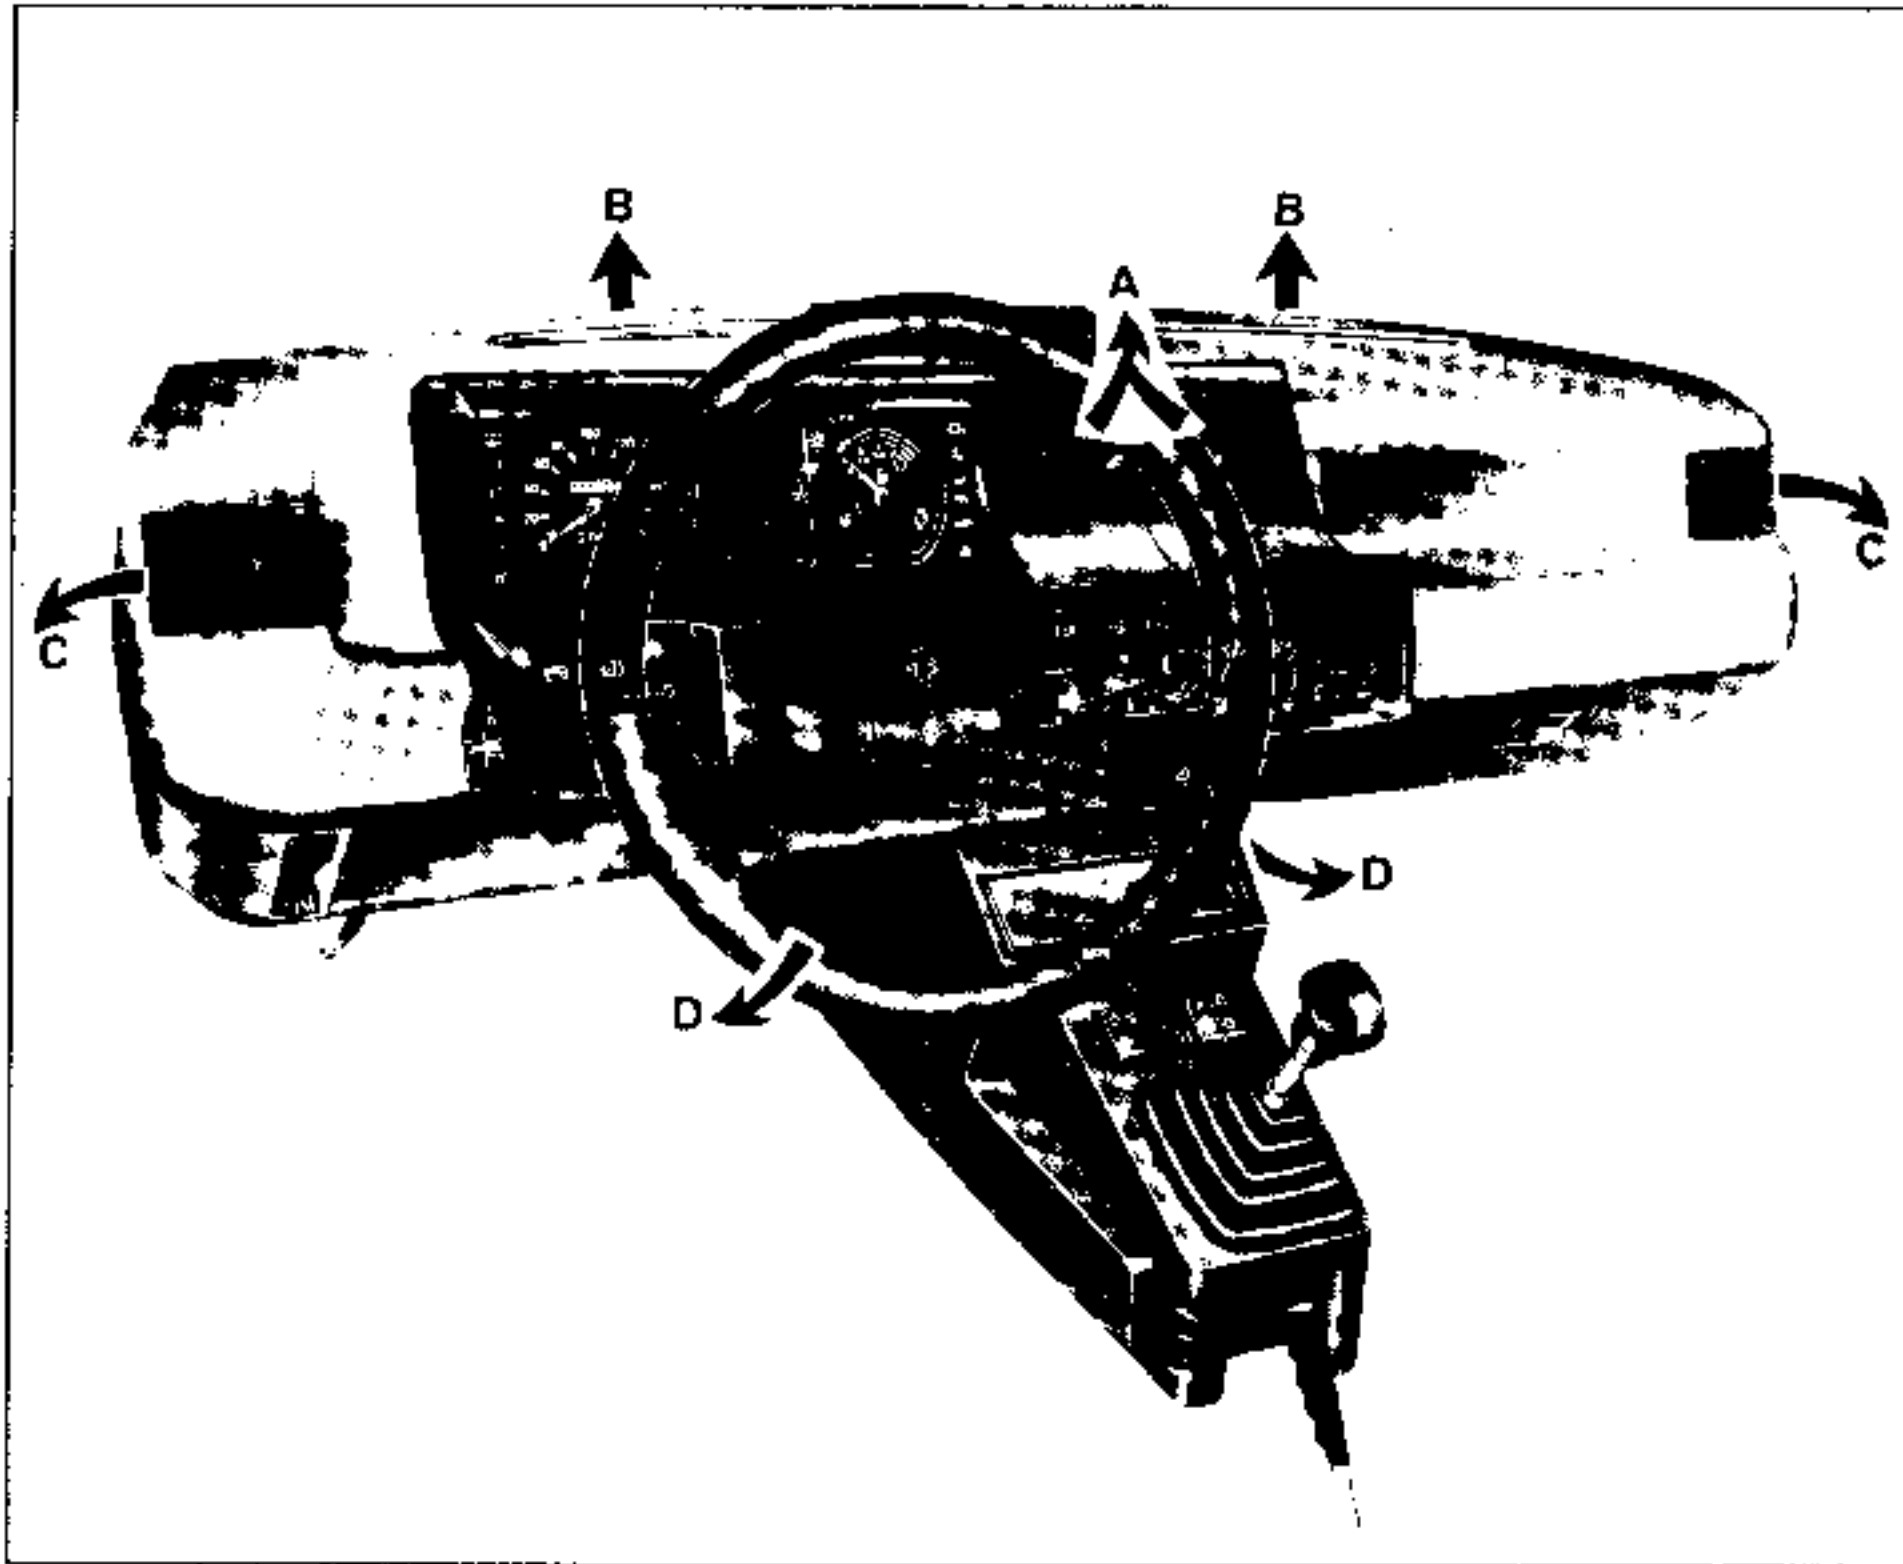
- A Central ventilator outlets
- B Windscreen demister outlet
- C Dashboard ventilator outlets
- D Lower ventilation outlet.

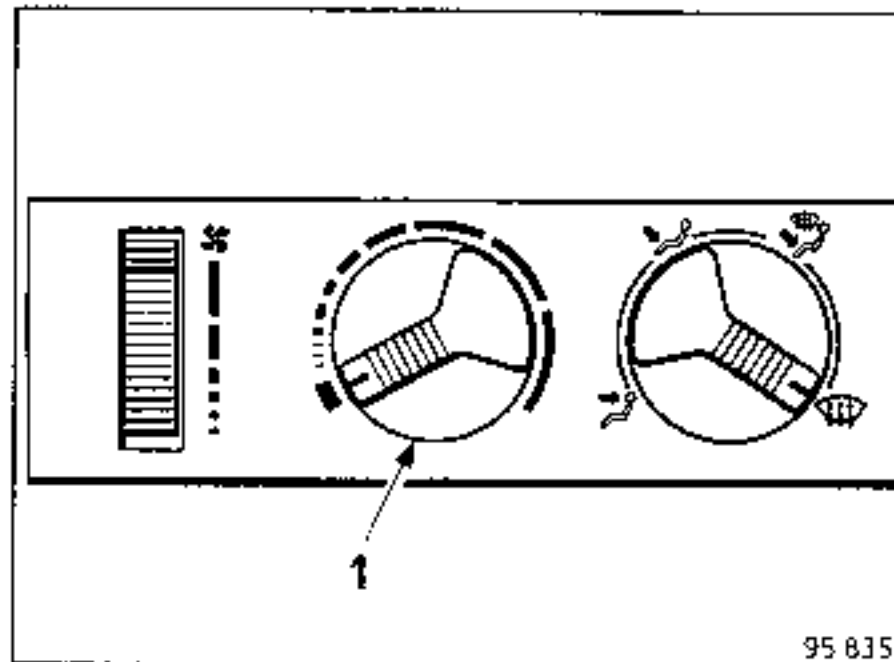
TEMPERATURE ROTATING CONTROL SWITCH (1)

Turn the rotating switch (1) to obtain the required temperature.

When the rotating switch is in the extreme left position, the air is not heated, and is therefore at the minimum possible temperature.

When the air conditioning control (4) is on a position other than - O -, the air is first cooled and dried as it passes through the evaporator, then a certain amount is reheated by passing across the radiator.

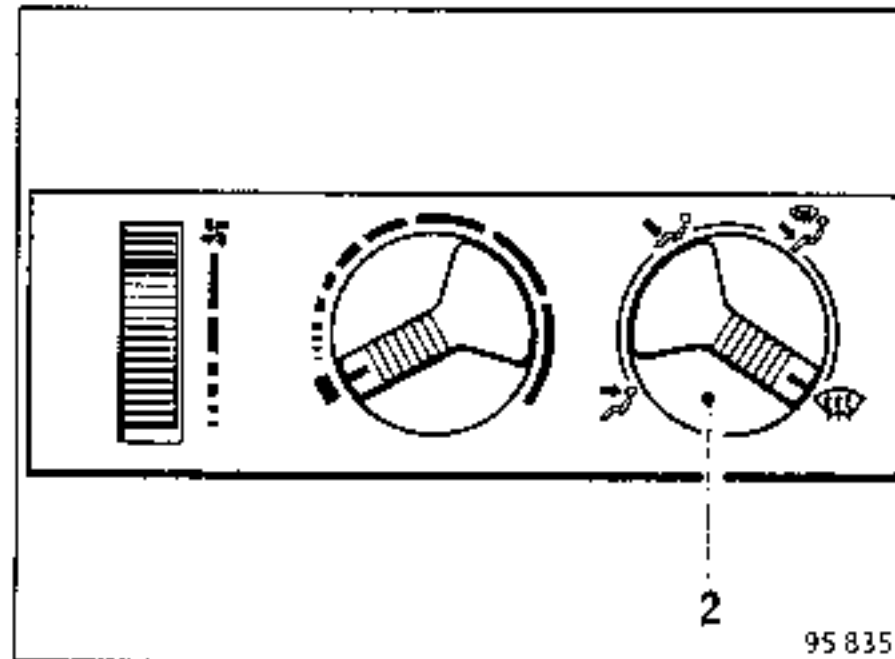
AIR DISTRIBUTION SWITCH (2)

The air flow is directed to the dashboard ventilators (A) and (C) only.

The air flow is directed to all ventilators (A), (B), (C), (D).

The air flow is directed to the lower ventilators (D) and the dashboard ventilators (A) and (C).

The air flow is directed to the windscreen ventilators (B) and the dashboard ventilators (A) and (C).

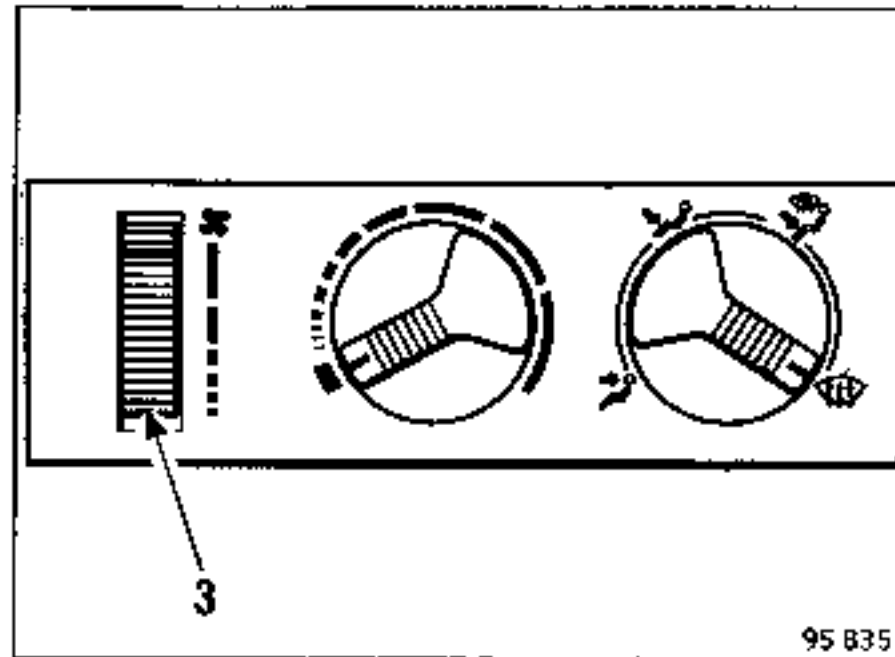
FAN CONTROL WHEEL (3)

Ventilation is said to be by using blown air
The air flow circulating in the passenger compartment is controlled by the positions on the control wheel (3)

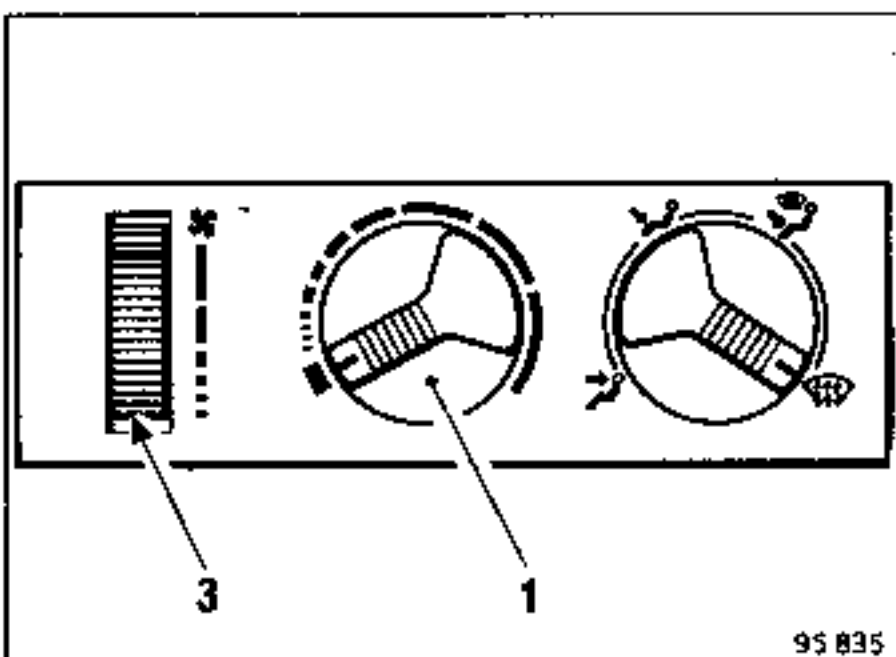
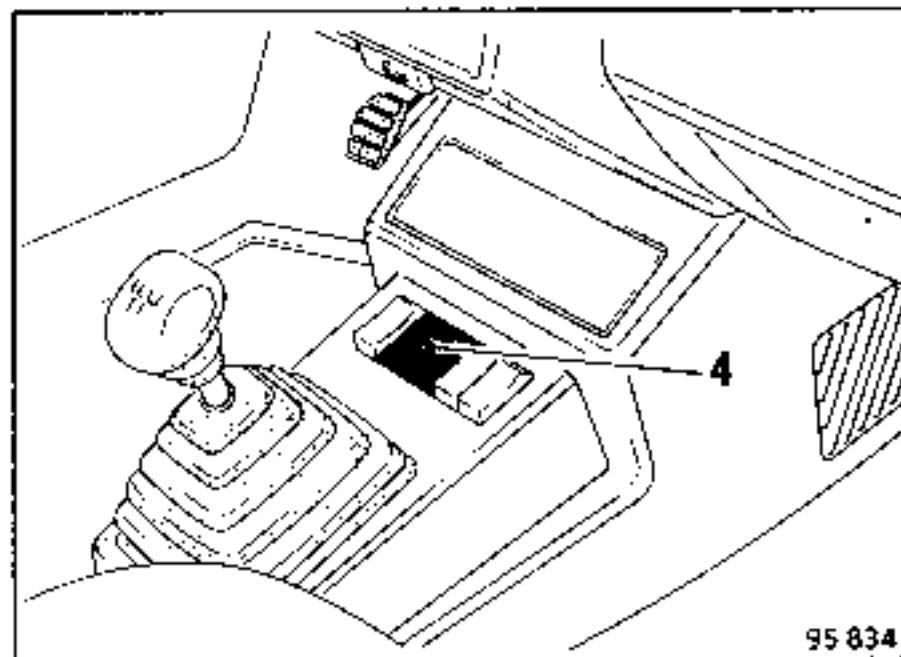
AIR CONDITIONING CONTROL KEY (4).

This control switch stops or starts air conditioning

– **POSITION 0** : Air conditioning is not operational, the heating and ventilation system has the same functions as a vehicle not fitted with air conditioning.

- **POSITION "AC"** : – Place the rotating switch (1) on the all cold position (blue spot)
- Place the air flow control wheel (3) on at least the lowest speed.
 - Adjust the temperature using key (4) (Adjustment range between 0 and 15°C).

The air conditioning is operational. Air is taken from the passenger compartment and recycled, without taking air from outside the vehicle

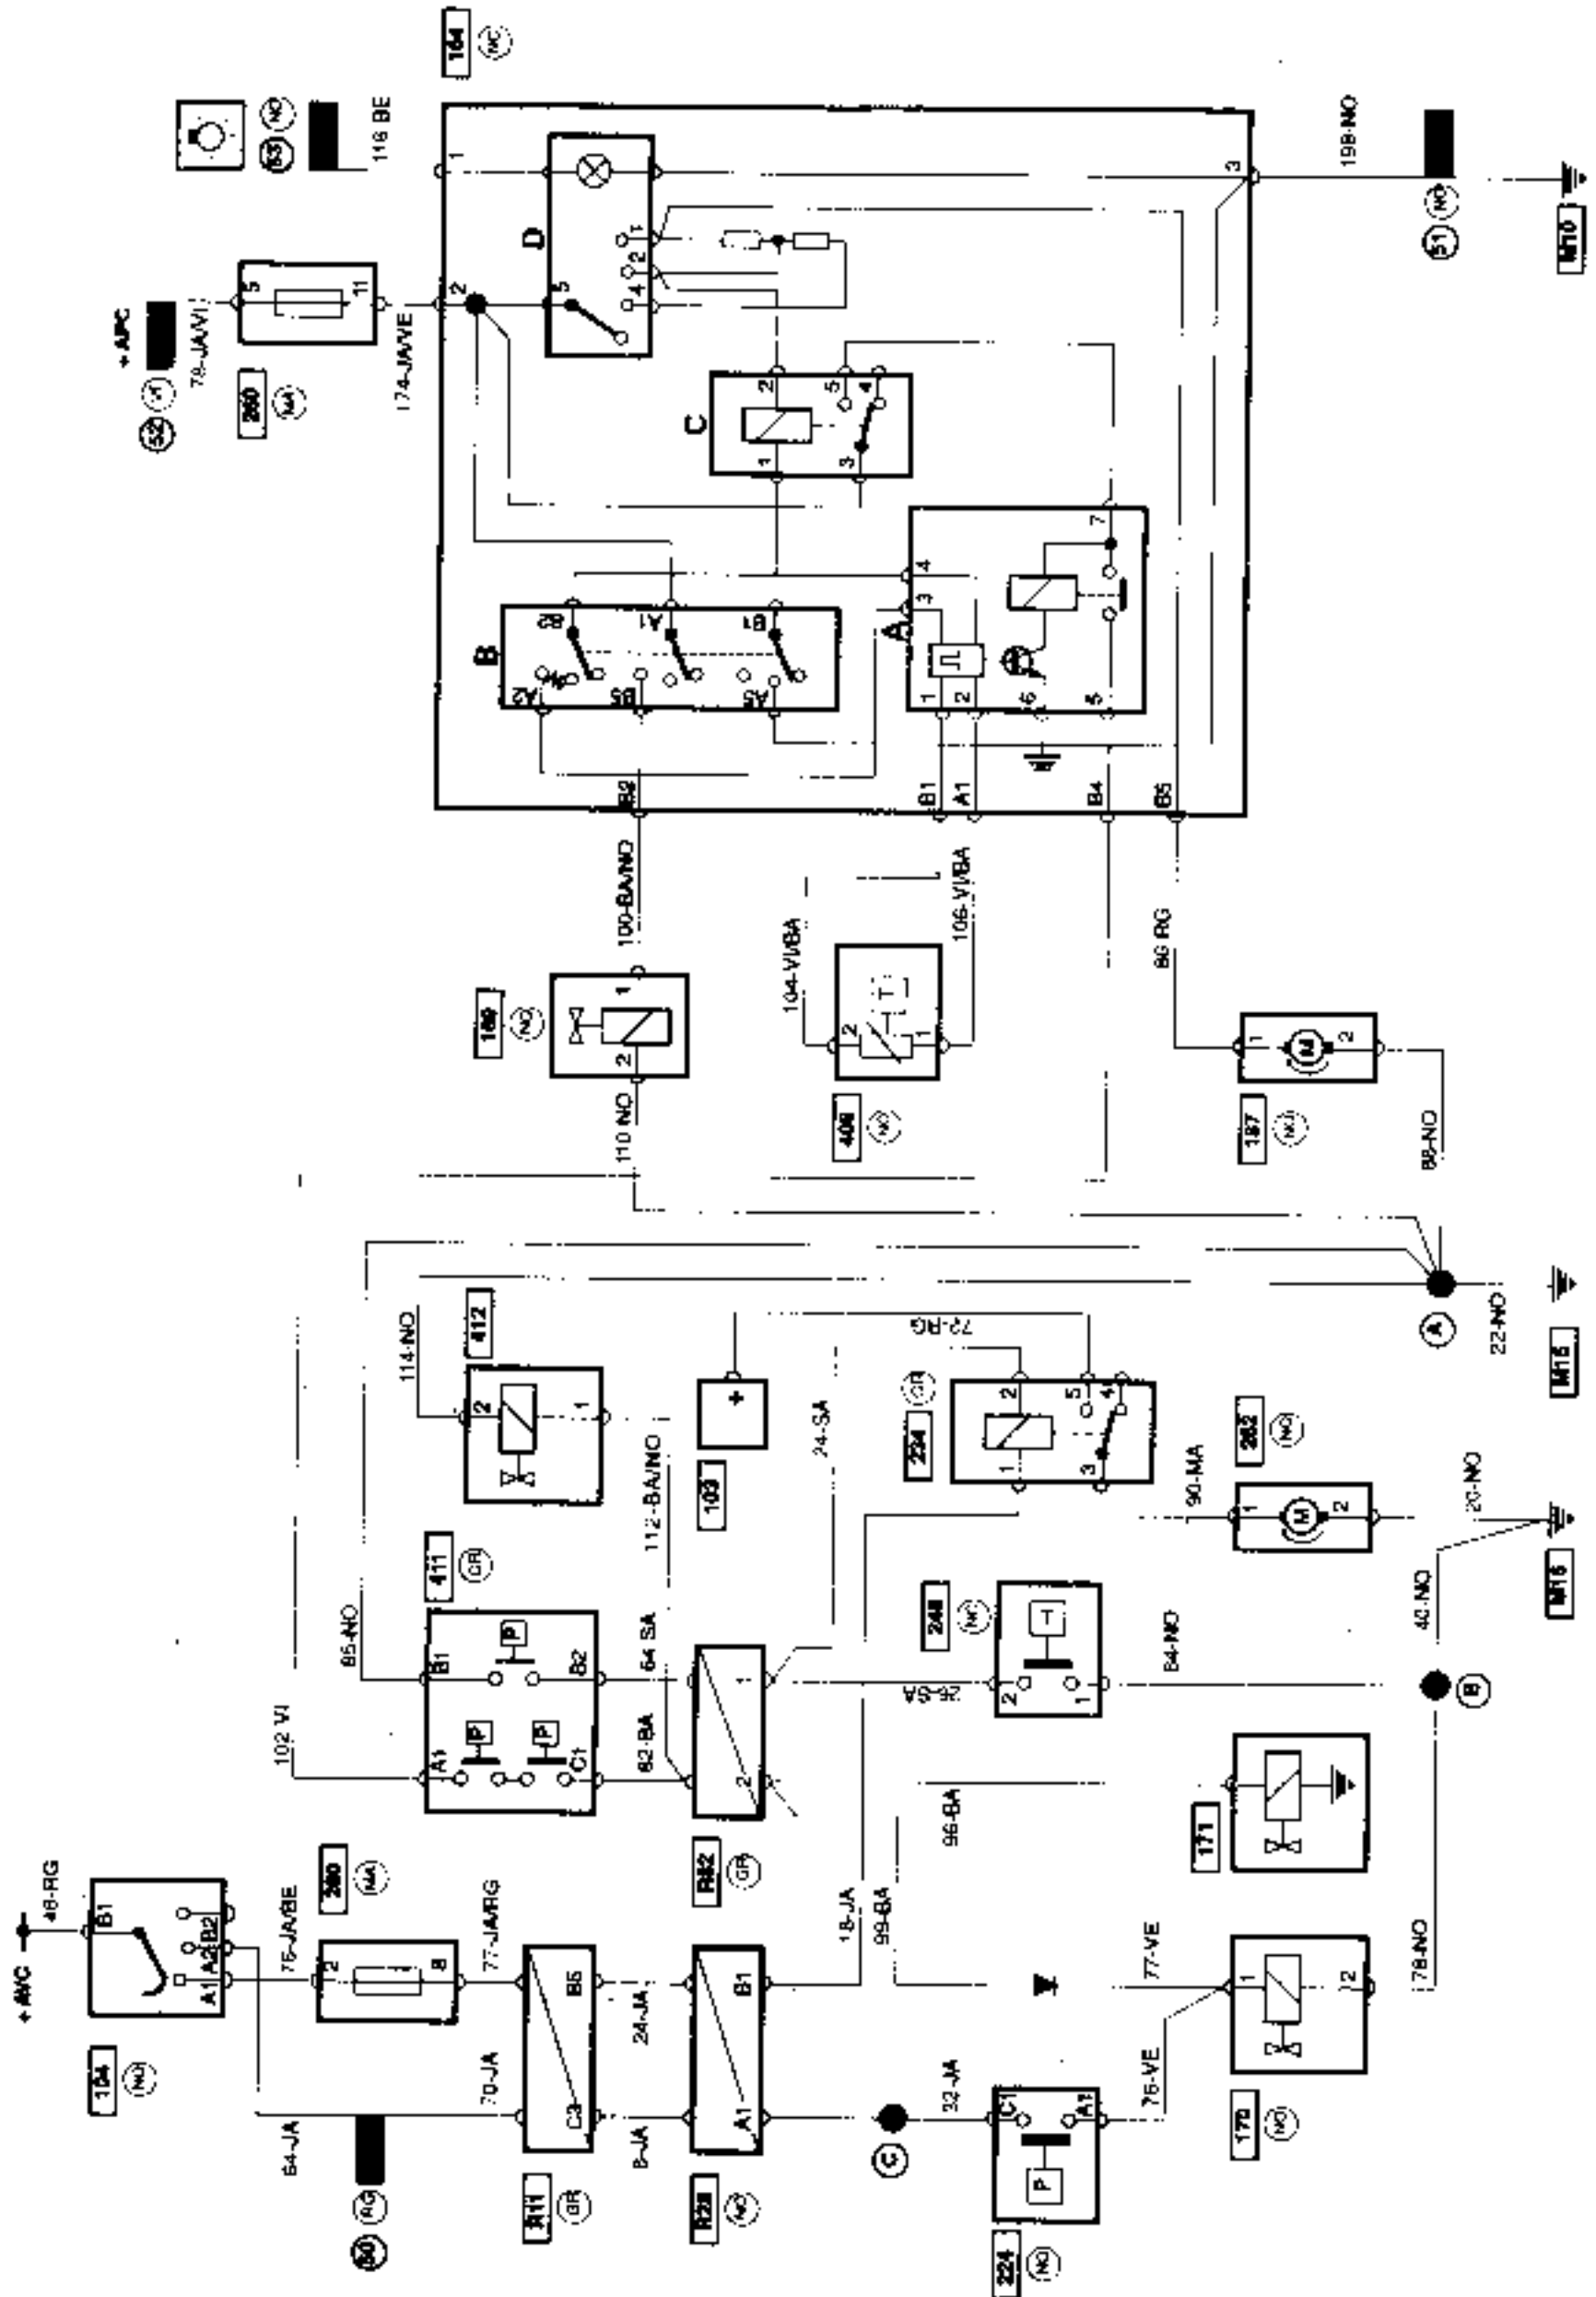
E 6 J engine with power assisted steering

Wiring diagram

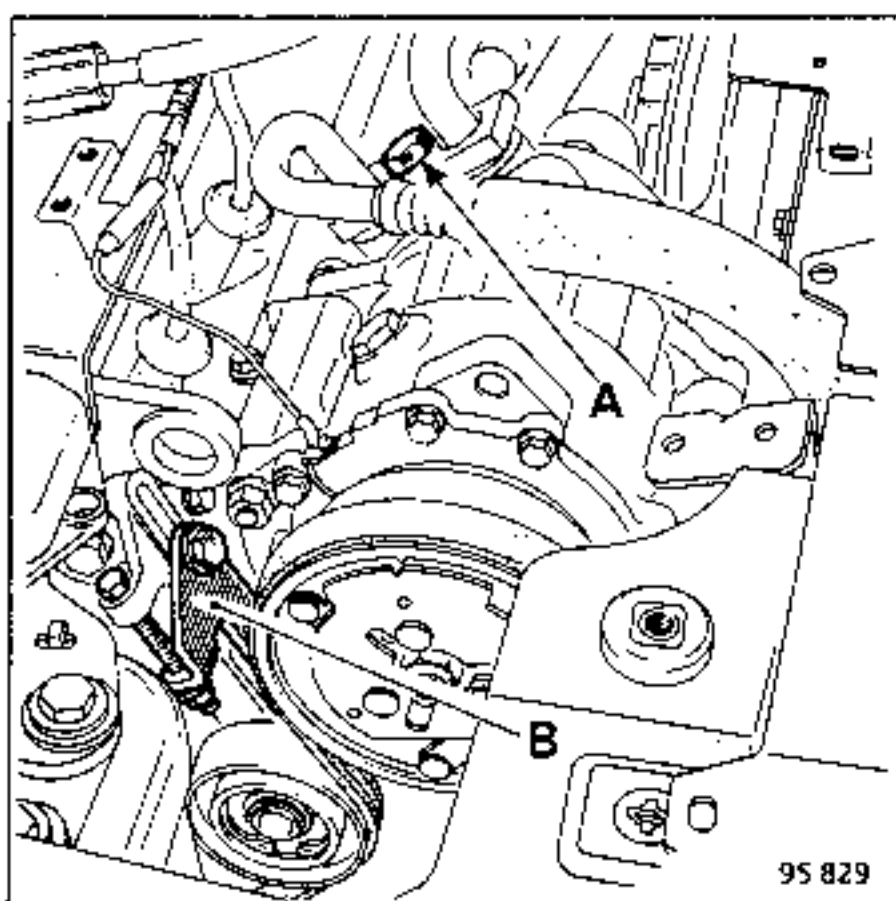
- Disconnect the battery.
- Remove the bonnet.
- Remove the upper cross member (without removing the radiator grille).
- Drain the freon circuit (see method in "Air conditioning" manual).
- Remove the retaining bolts (A) for the connection pipes.

- Loosen the tensioner mounting (B) and slacken the belt (the headlight bulb cover may have to be removed).
- Remove the drive belt
- Disconnect the compressor feed wiring
- Remove the two compressor mounting bolts and remove the compressor upwards.

Torque tighten the pipe retaining bolts (A) to $3,5 + 0,5 \text{ daN.m.}$

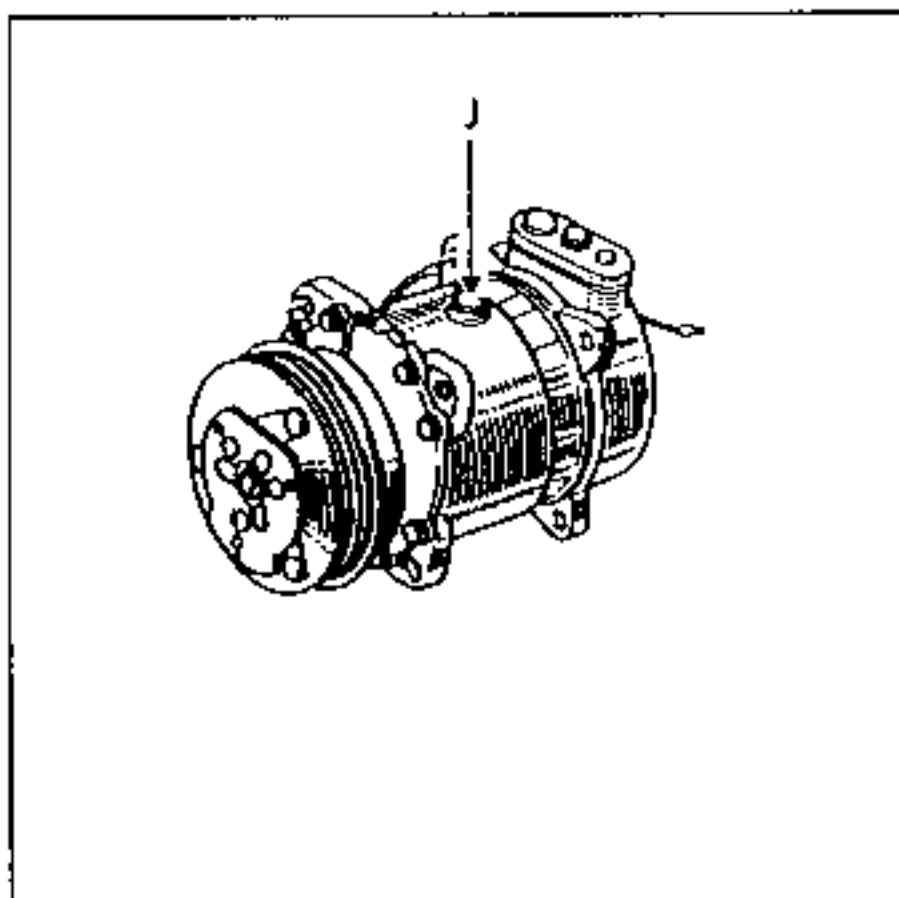
Unscrew and remove the oil plug (J).

Tip the compressor upside down and let the oil drain out from the housing (to drain as much oil as possible, turn the housing by hand).

Fill the compressor with 120 cm³ (15 cm³ is taken as remaining in the compressor after draining), of **ELF RIMA 100** oil (approx. 1 glass).

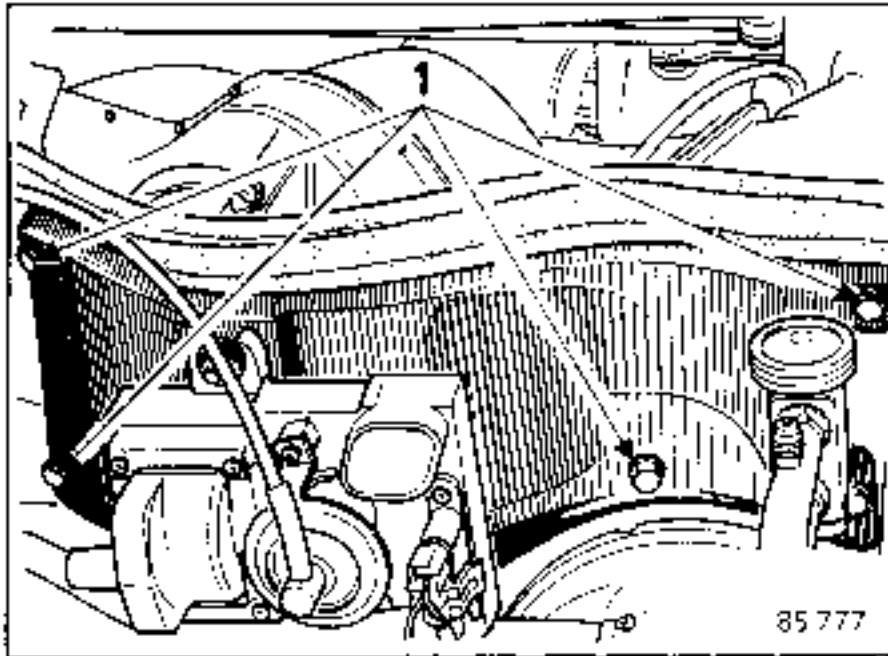
- Remove the battery.
- Remove the A.E.I (for carburettor versions) or the M.P.A (for injection versions).
- Remove the 6 mounting bolts (1) from the water reservoir section.

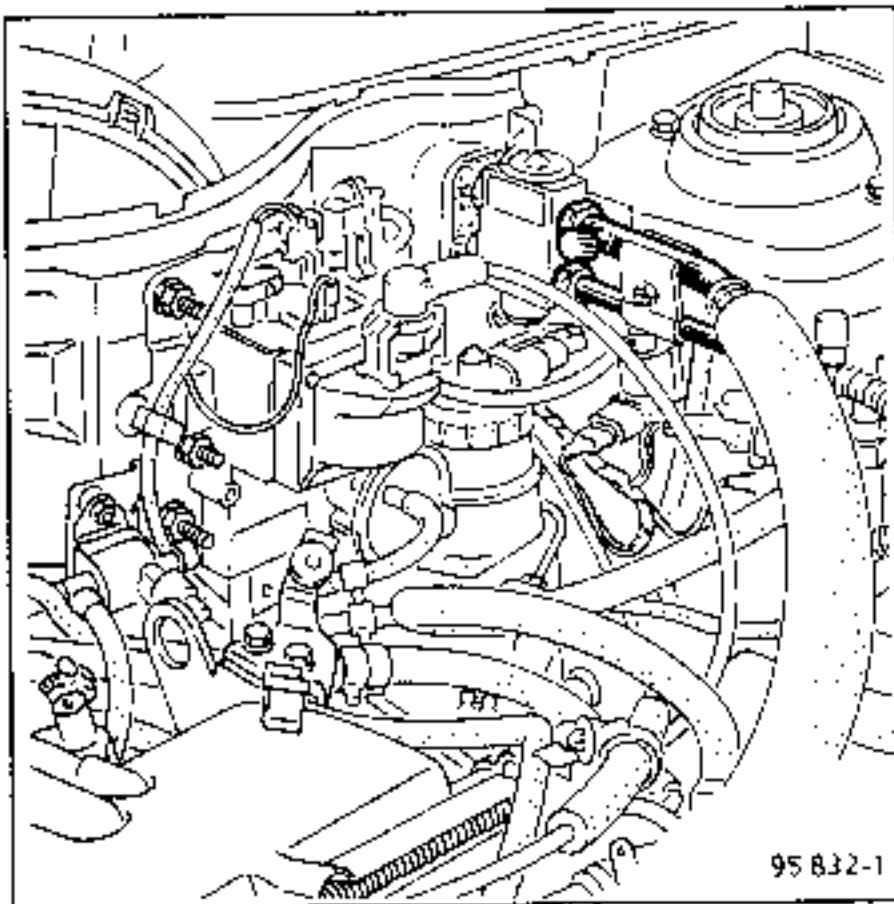
- Drain the freon circuit at the filling point (see method in "Air conditioning" manual).
- Disconnect the freon pipe connections

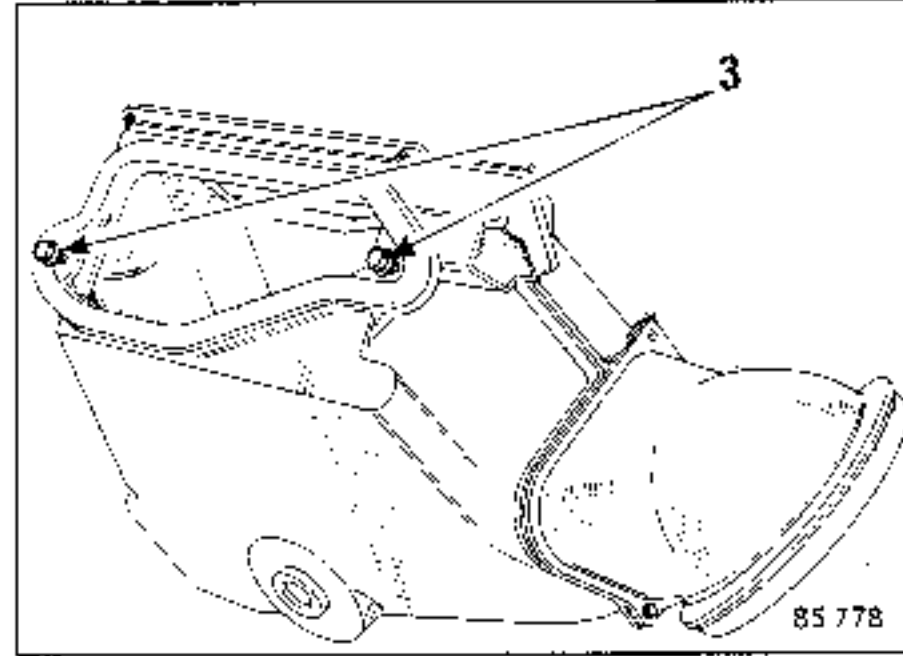
- Remove the two mounting bolts for the cooling fan assembly and remove the fan.
- Remove the two mounting bolts for the evaporator (3) (bolts can be removed from inside the vehicle without removing the dashboard).
- Remove the evaporator.

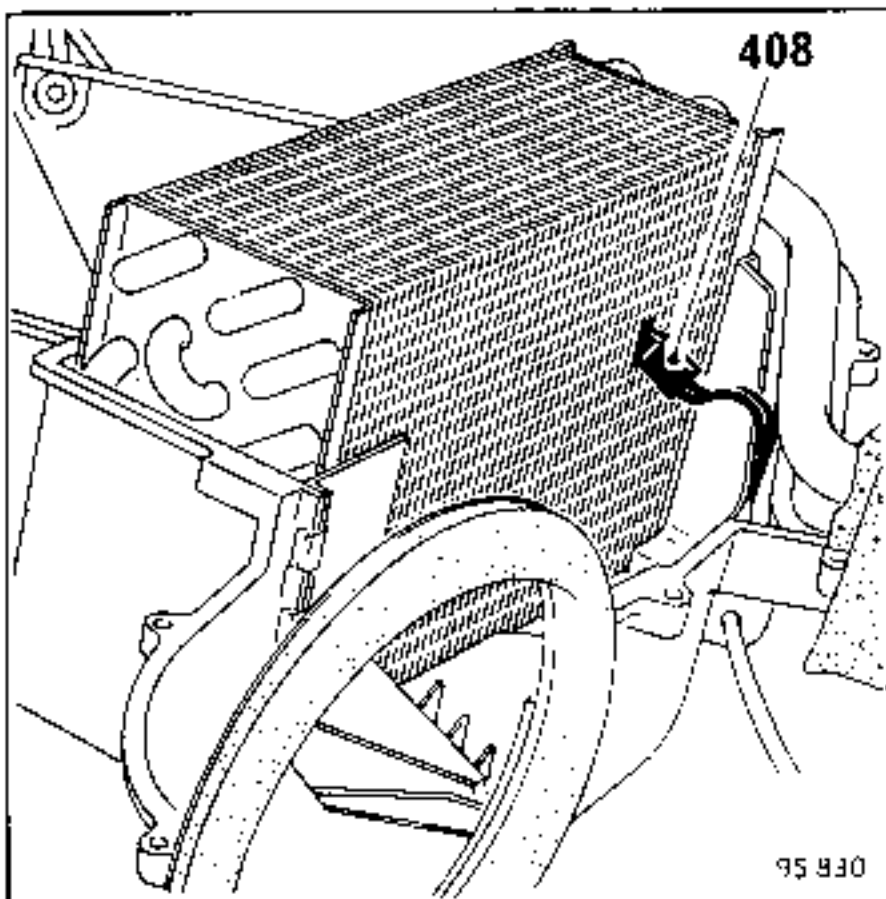
EVAPORATOR SENSOR (408)

The evaporator sensor is mounted between two of the evaporator wings.

To reach the sensor, remove the evaporator unit (see corresponding chapter) and release the two half housings.

10° C	10 000 Ω
15° C	7 500 Ω
20° C	6 000 Ω
25° C	4 750 Ω
30° C	4 000 Ω
35° C	3 000 Ω

The sensor should be tested in place, with the fan running at high speed, between the two tracks of the connector on the water reservoir.

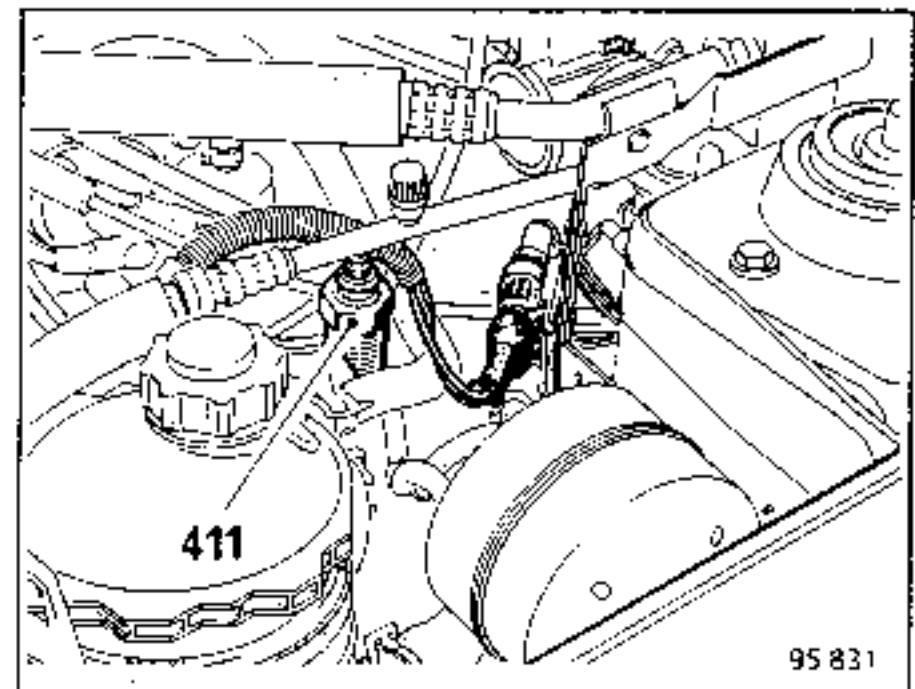
TRIFUNCTION PRESSOSTAT (411)

The pressostat ensures the min and max operating pressures for the cooling circuit.

- Low pressure cut-off threshold **2 bars**.
- High pressure cut-off threshold **28 bars**.
- Fan high speed threshold **19 bars**.

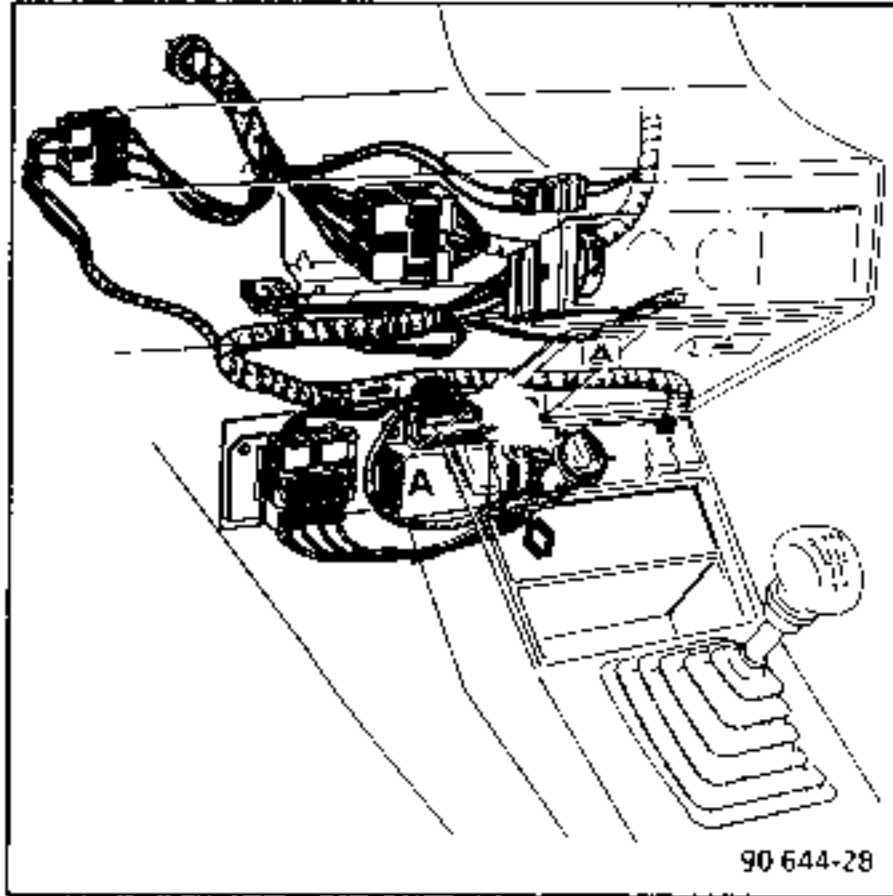
ELECTRONIC MODULE (A)

The electronic module is mounted on the air distribution chamber body.

To reach the module, remove the centre console from inside the vehicle.

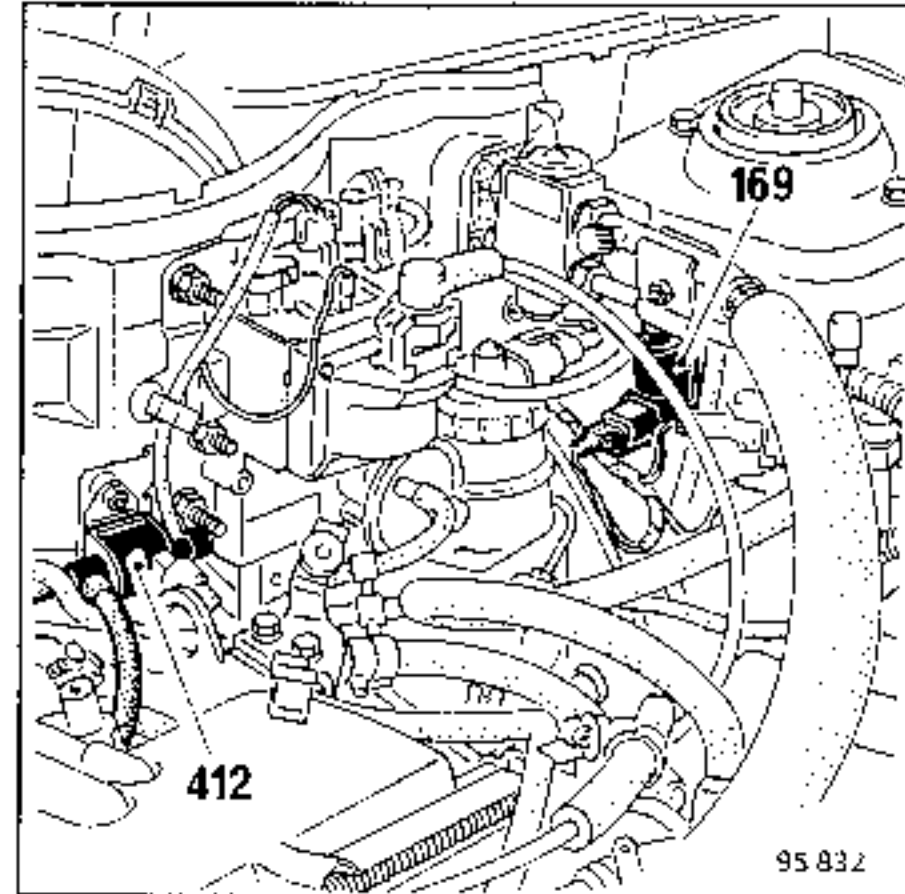
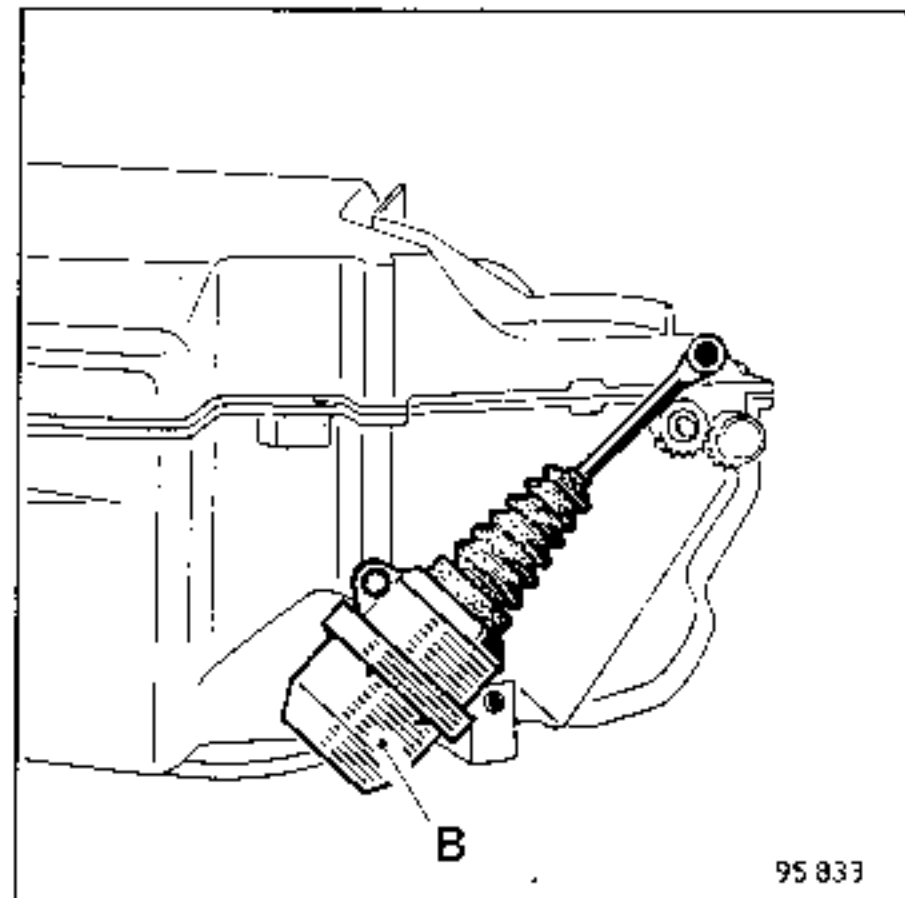
RECYCLING FLAP SOLENOID VALVE

The solenoid valve (169) when energised, activates the pneumatic valve (B) to close the external air entry flap.
