INSULTING THE RENAULT 5 TURBO 2

by Simon Ashley – January 1996

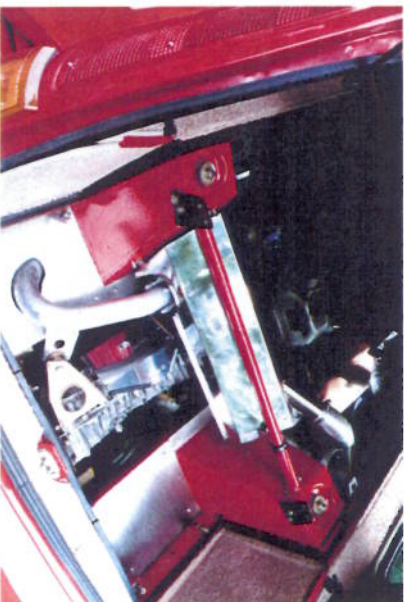
The engine bay in a Turbo 2 is often dominated by the poor condition of the insulating material of the rear bulkhead and also the fuel tank cover. The appearance of these areas can easily be enhanced for a modest outlay whilst reducing the heat – soak into the cabin. Certain improvements can also be effected in the engine bay to reduce the transmission to vital components in the engine bay.

The area that benefits most from re-insulation is the fuel tank cover as this is easily seen and is often in the poorest condition of all the insulation in the bay. The first step to renovating any part of the insulation is removal of the old aluminium foil from the woven fibre glass cloth, this is tedious and ideally gloves should be worn. Once this is complete the fibreglass cloth should be cleaned gently with a mild detergent taking care not to damage the material in any way. The fibreglass cloth can then be covered with a modern aluminium foil matting which for best results should entrap the old cloth by folding the matting around the edges. This is best achieved by laying the old cloth

on top of the new matting and leaving a 2.5cm border using the cloth as a template when cutting. A spray adhesive should then be used to glue the new cloth to the matting, finally the edges should be glued to the rear of the existing cloth. The results are unbelievable, especially when the small time this takes to complete. I have made a small change to the way in which the insulation to the small fuel tank is arranged. The folded over portion of the original has been removed and two non-overlapping panels now cover this area. This is far neater and it is likely to peel away during service. Another area where this type of matting can be employed is under the exhaust, which has a tendency to scorch the paint underneath. The matting is

again cleaned and then stuck directly to the car. Any loose or uncovered edges should be sealed with aluminium repair tape, this is readily available from any DIY store. The results of these improvements is immediately apparent from a visual point of view and also from the greatly improved heat insulation which obviously prevents heat – soak into the cabin. The matting is available from Merlin Motorsports who are based at the Castlecombe circuit. Unfortunately I have yet to find anyone who can supply new fibreglass cloth of the type used in this car.
