**RENAULT** X40

**MOUNTINGS MAKING UP THE DOORS**

**TECHNICAL  
NOTE**

**116**

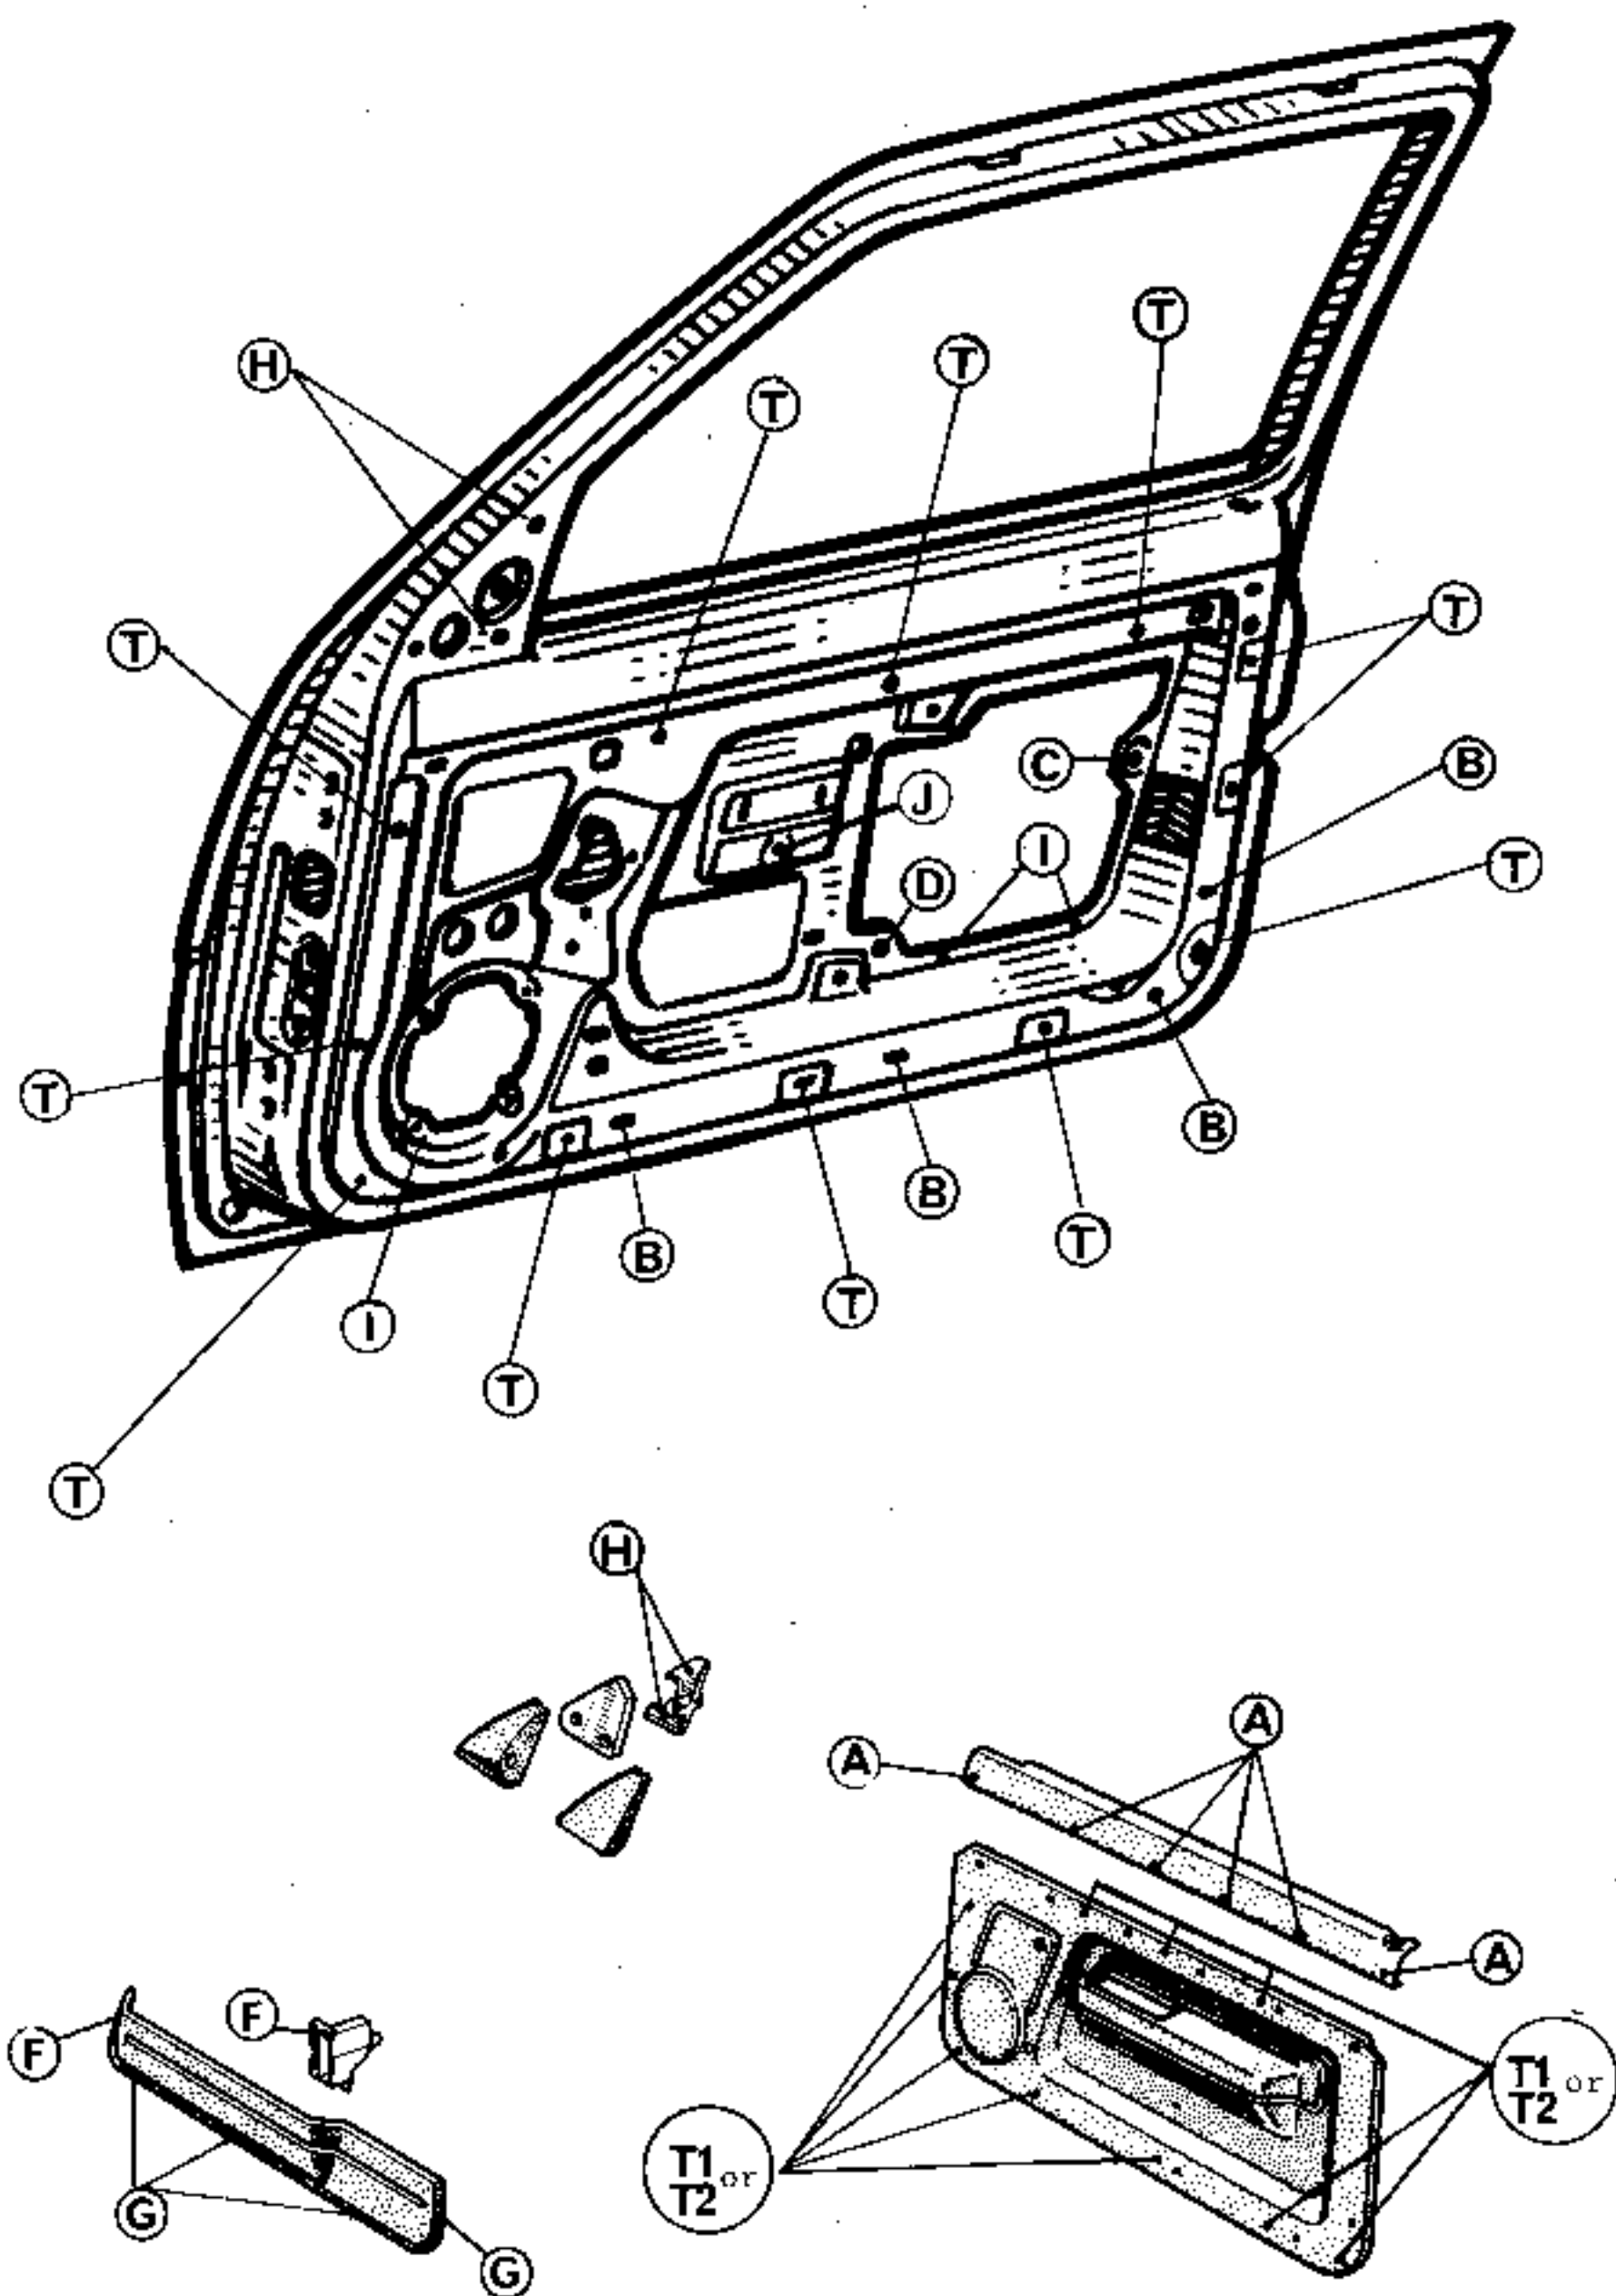
#### **1 - CAUSE**

Difficulty in positioning all the door trim fastenings correctly and dismantling-reassembly method.

#### **2 - RISK**

Incorrect assembly.

3.1 Diagram illustrating the securing points.

Use tool D 115 to unpick the trims fastened with clips (of the pressure stud type).
